Phase III Redevelopment of The Hong Kong Federation of Youth Groups Jockey Club Sai Kung Outdoor Training Camp

Environmental Monitoring and Audit Report for August 2011

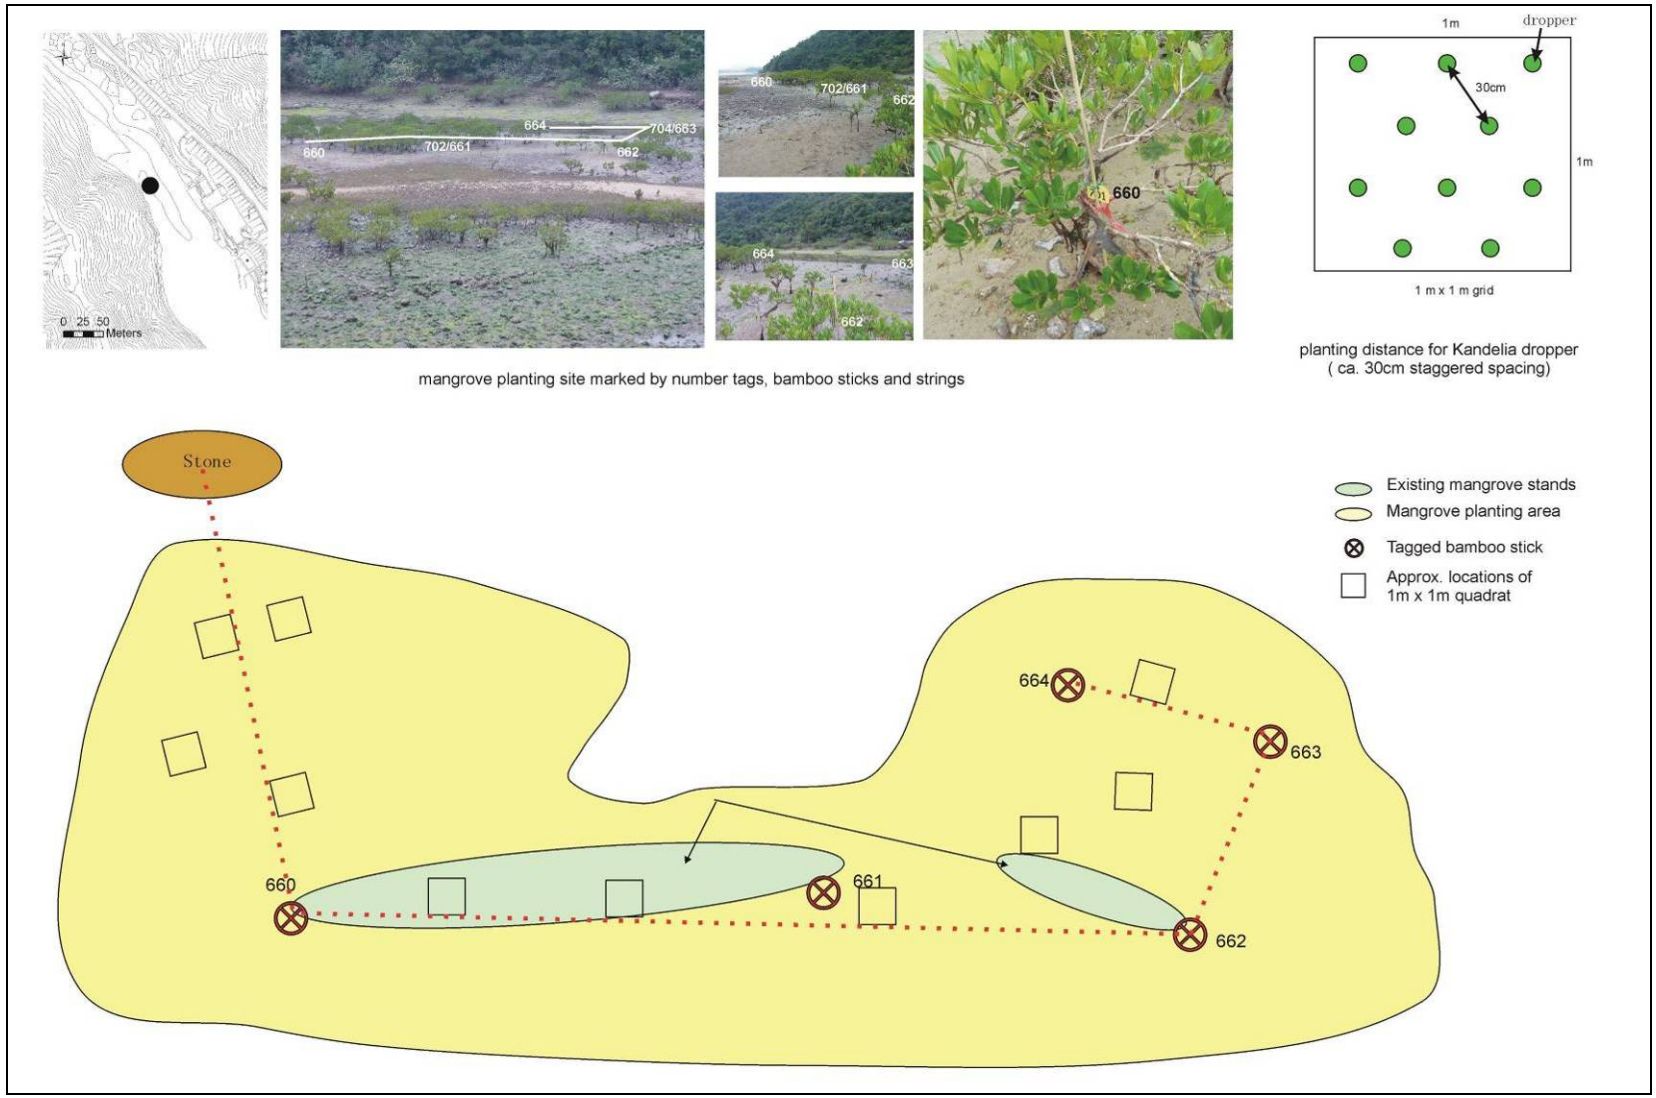
Figure 5.1 Mangrove Compensatory Planting Site and Sampling Locations

5.2.3 Mangrove monitoring was conducted on 29 August 2011. 10 1m x 1m quadrats were set. Number of mangrove seedlings was counted, and height measured from ground level (including length of the exposed dropper) to the top of the seedling to the nearest cm. The health condition of the planted seedlings was also noted. Photo records of the mangrove plantings were taken (**Figure 5.2**).

5.2.4 A total of 53 no. of Kandelia seedlings with an average height of 27.0 cm were recorded in the 10 quadrats (**Table 5.1**). The number of recorded seedlings decreased probably due to grazing as a feral cattle was observed wandering on the sandflat by camp staff. Little signs of uprooting or grazing of the planted seedlings were observed outside the quadrats. The health conditions of the remaining seedlings were good. The average height increased (**Appendix H**), and most of the seedlings displayed 4-5 pairs of young leaves. Advice was given to camp staff to deter feral cattle from approaching the mangrove planting area as possible in the future.
