Phase III Redevelopment of The Hong Kong Federation of Youth Groups Jockey Club Sai Kung Outdoor Training Camp

Environmental Monitoring and Audit Report for February 2012

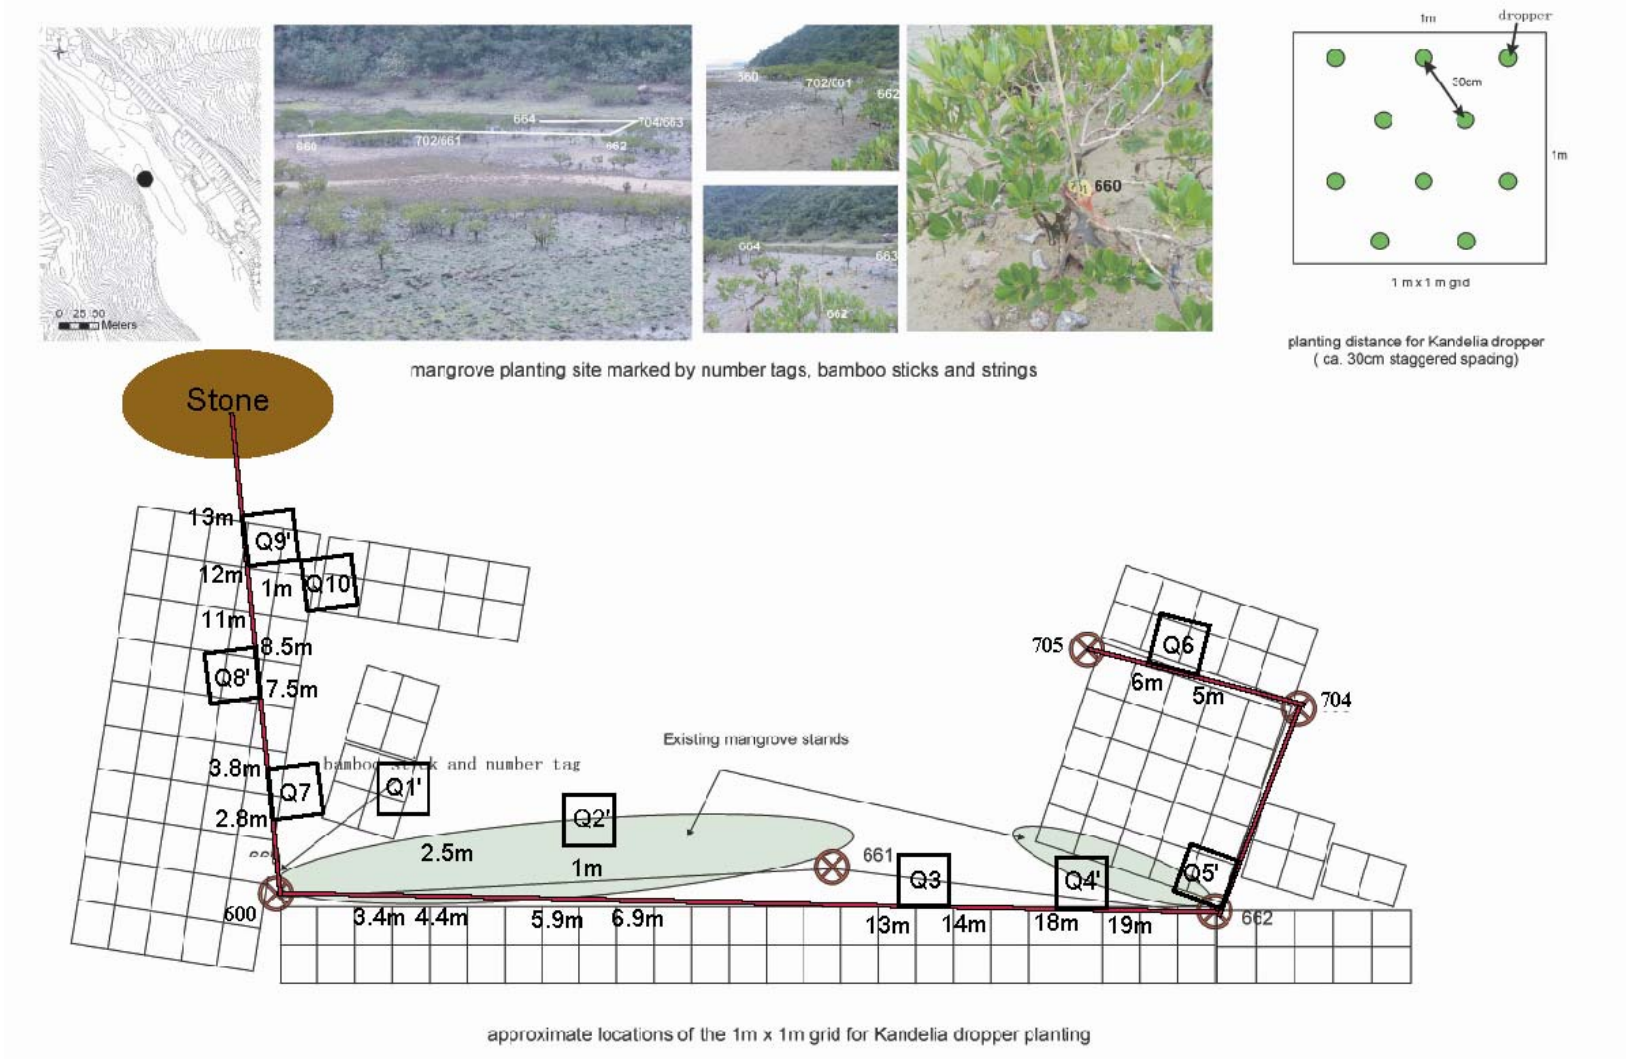
Figure 5.2 Photo Records of Mangrove Seedlings

5.2.4 A total of 16 seedlings with an average height of 15.3 cm was found survived within the 10 quadrats (**Appendix H**). New leaves were observed resprouted from the grazed seedlings, although the health conditions were fair to poor. Some seedlings were also covered by algae, which always occur in early spring season. Head count of survived seedlings was conducted, and a total of about 120 seedlings remained.

5.2.5 Although the average height was reduced and percentage survival was low, regeneration of new leaves observed indicated that there may be more seedlings considered “dead” resprouting in the coming growing season. Mangrove planting however will be carried out as part of the nature conservation education programme as before. Monitoring will continue in May 2012.

overview of the planting area	 laying of transect	 sampling within quadrat
 growth of seedling near mature stand	 resprouted new leaves	 seedling covered by algae

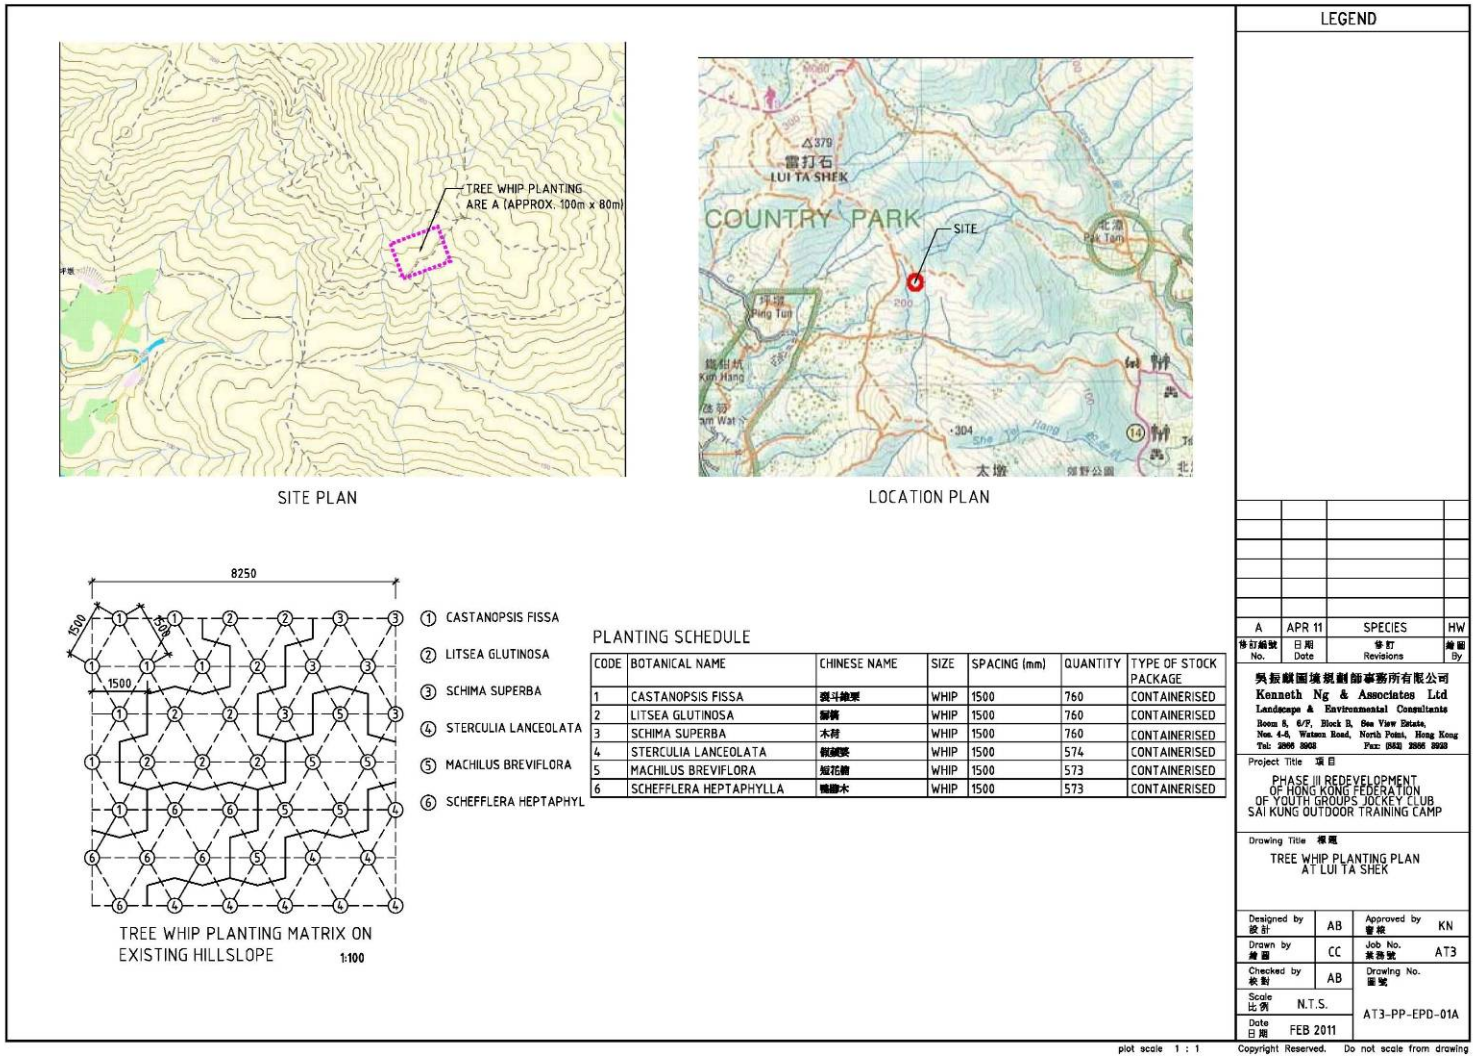
Figure 5.4 Photo Records of Woodland Compensatory Planting at Lui Ta Shek

5.3.4 Similar to the observation made in November 2011, individuals of the six planted species were in fair to poor conditions. *Schefflera heptaphylla,* and *Schima superba* was in fair conditions, where healthy leaves and little signs of insect attack or desiccation were observed. Other species, including *Castanopsis fissa, Machilus* sp., *Sterculia lanceolata*, and *Litsea glutinosa* suffered from various degree of herbivory and desiccation. Dead seedlings were also observed, although a few resprouted, which are signs of regeneration. Monitoring will continue to audit the replacement planting to be conducted in April 2012 and check the growing conditions of the plants.

Schefflera heptaphylla	 Schima superba	 Castanopsis fissa
 Sterculia lanceolata	 Dead seedling	 Resprout from base of seedling

The landscape contractor was informed regarding the situation and reminded of the required remedial and maintenance work. It was reported with photo records by the landscape contractor that firming up for the seedlings was conducted in November 2011. A remedial action proposal including replacement planting in April 2012 was submitted to the Project Proponent.
