Phase III Redevelopment of The Hong Kong Federation of Youth Groups Jockey Club Sai Kung Outdoor Training Camp

Environmental Monitoring and Audit Report for May 2012

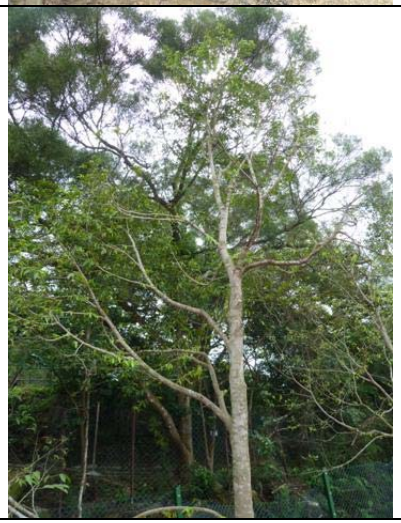
Figure 4.2 Photo Records of Transplanted Trees

5.1.1 Transplantation of the Incense Trees *Aquilaria sinensis* was completed on 12 March 2012. Transplanted tree monitoring was conducted monthly for the first three months from March to May 2012 and then will be conducted quarterly. Monitoring for the current session was conducted on 29 May 2012. The transplanted trees were in fair conditions (**Figure 4.2**). TR775 and TR766 were flowering, while TR644 ad TR639 had regenerating leaves. TR643 (Tree ID rectified as *Homalium cochinchinensis* finished flowering. No signs of disease or stress were observed. Monitoring will continue in August 2012.

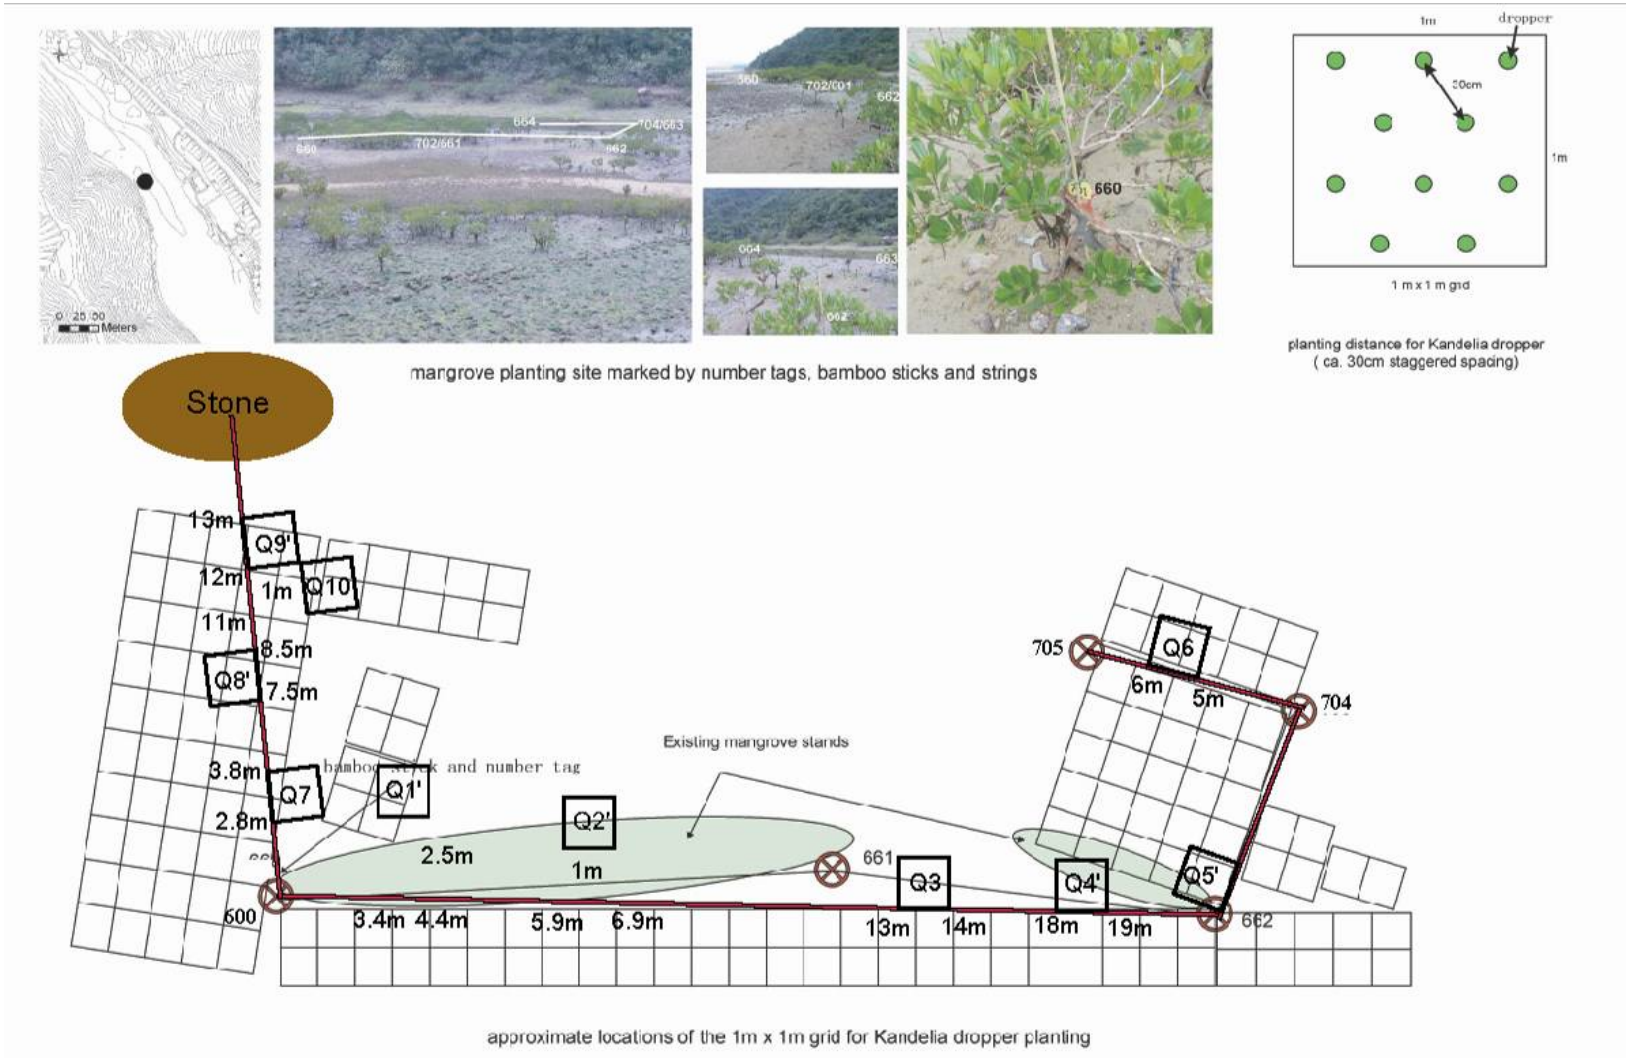
Figure 5.2 Photo Records of Mangrove Planting, May 2012

5.2.4 Monitoring was conducted on 31 May 2012. A total of 22 seedlings with an average height of 15 cm was found within the 10 quadrats (**Appendix H**). The health condition was fair. New leaves were observed from the newly planted seedlings. Photo records of the mangrove plantings were shown in **Figure 5.2**. Monitoring will continue in August 2012.
