Phase III Redevelopment of The Hong Kong Federation of Youth Groups Jockey Club Sai Kung Outdoor Training Camp

Environmental Monitoring and Audit Report for August 2012

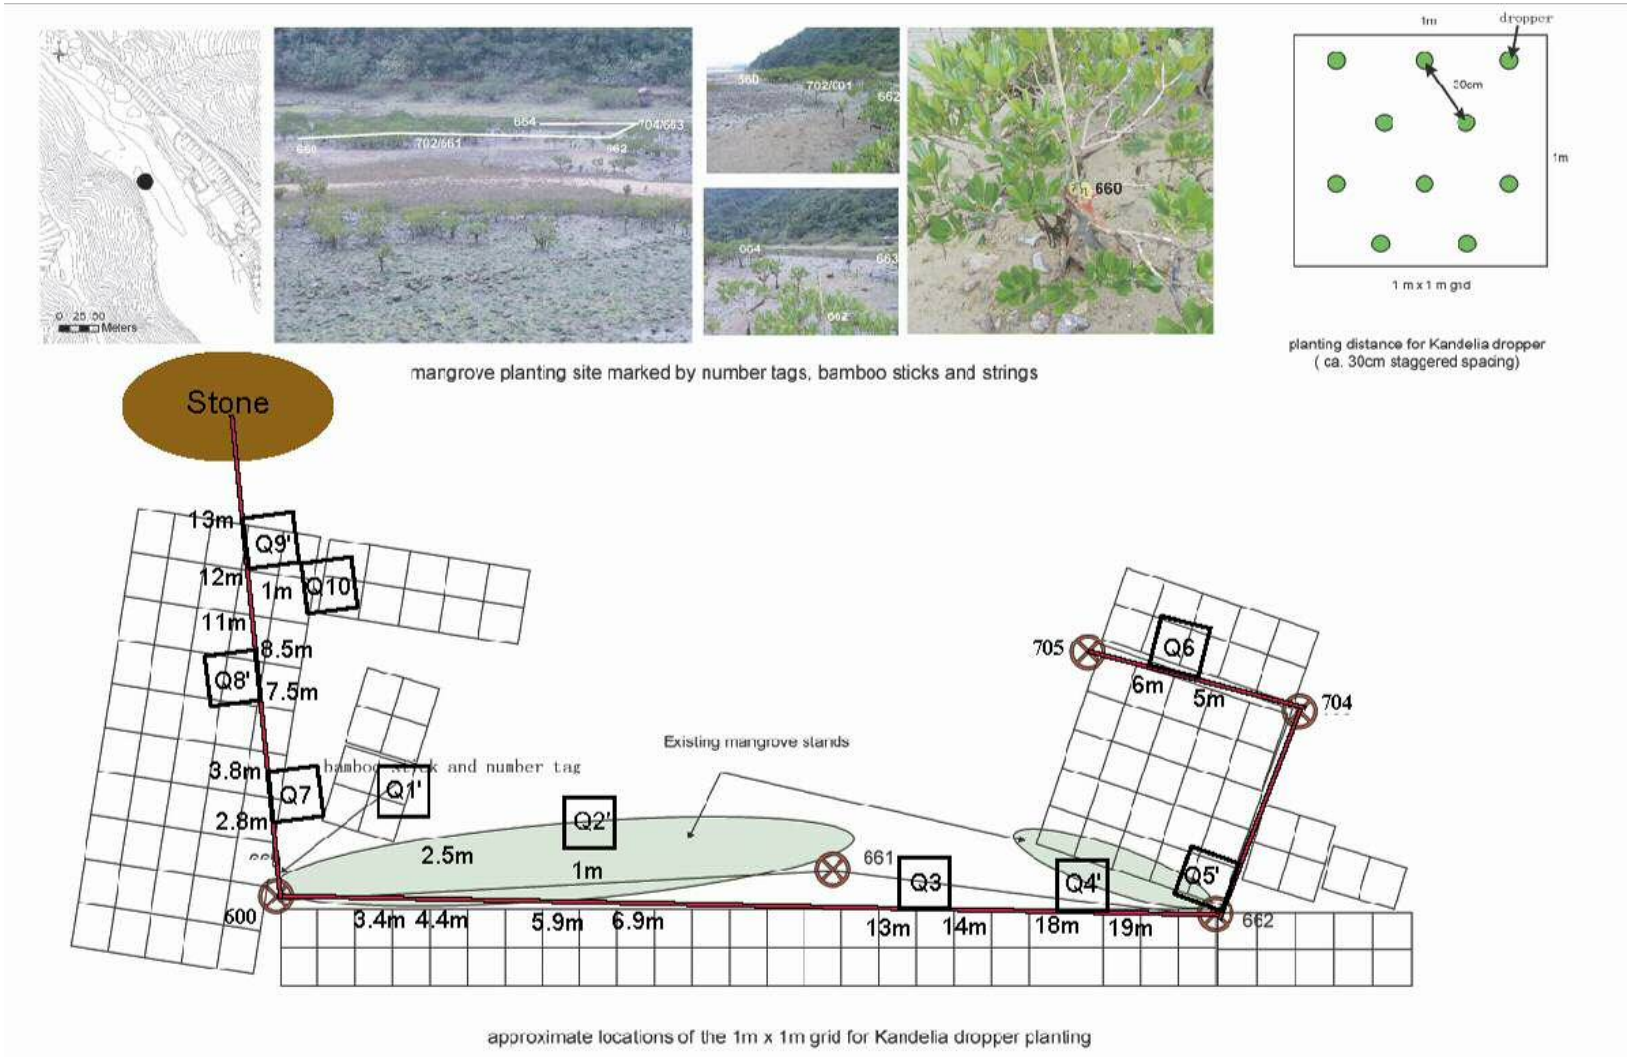
Figure 5.2 Photo Records of Mangrove Planting, August 2012

5.2.4 Monitoring was conducted on 23 August 2012, which was the last session of monitoring. A total of 23 seedlings with an average height of 23.1 cm was found within the 10 quadrats (**Appendix H**). The health condition was fair. New 3-5 pairs of leaves were observed from the newly planted seedlings. Photo records of the mangrove plantings were shown in **Figure 5.2**.

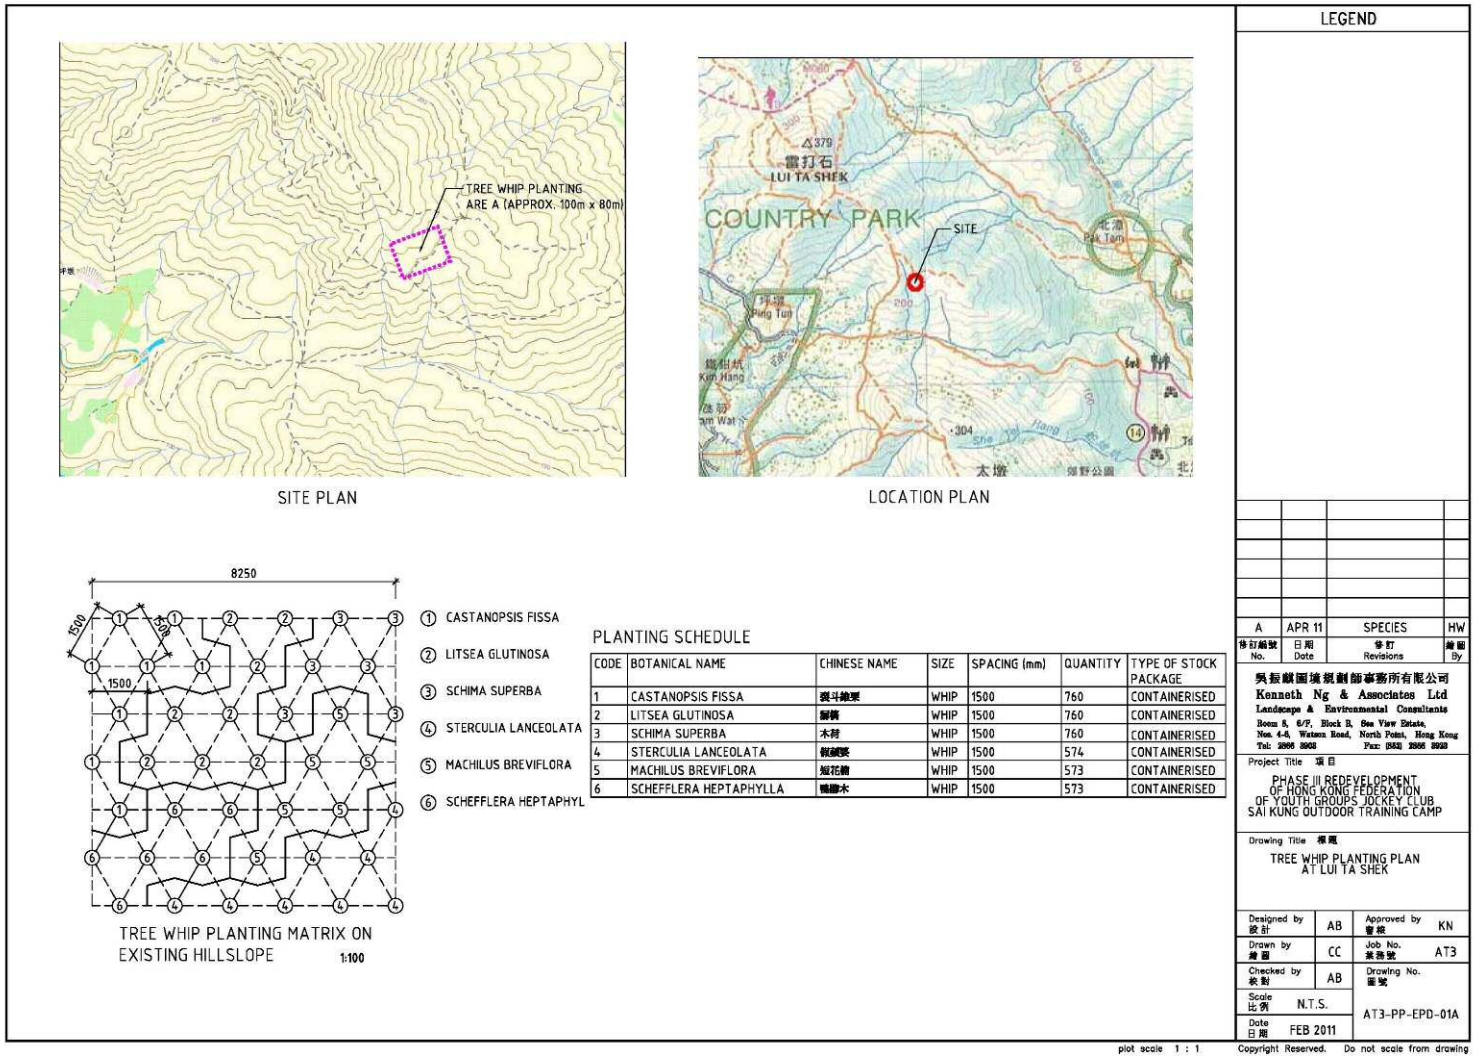
Figure 5.3 Tree Whip Planting Plan for Off-Site Woodland Compensatory Planting at Lui Ta Shek

5.3.4 Individuals of the six planted species were in fair to poor conditions. Of the survived seedlings, more individuals of *Schima superba* and *Schefflera heptaphylla* had new healthy leaves during this growing season and were in fair conditions. Other species including *Castanopsis fissa, Machilus* sp., *Sterculia lanceolata*, and *Litsea glutinosa* were in fair to poor conditions. Some of the individuals showed a few small resprouted leaves while herbivory were also observed. Monitoring will continue to audit the replacement planting to be conducted and check the growing conditions of the plants.
