Phase III Redevelopment of The Hong Kong Federation of Youth Groups Jockey Club Sai Kung Outdoor Training Camp

Environmental Monitoring and Audit Report for November 2013

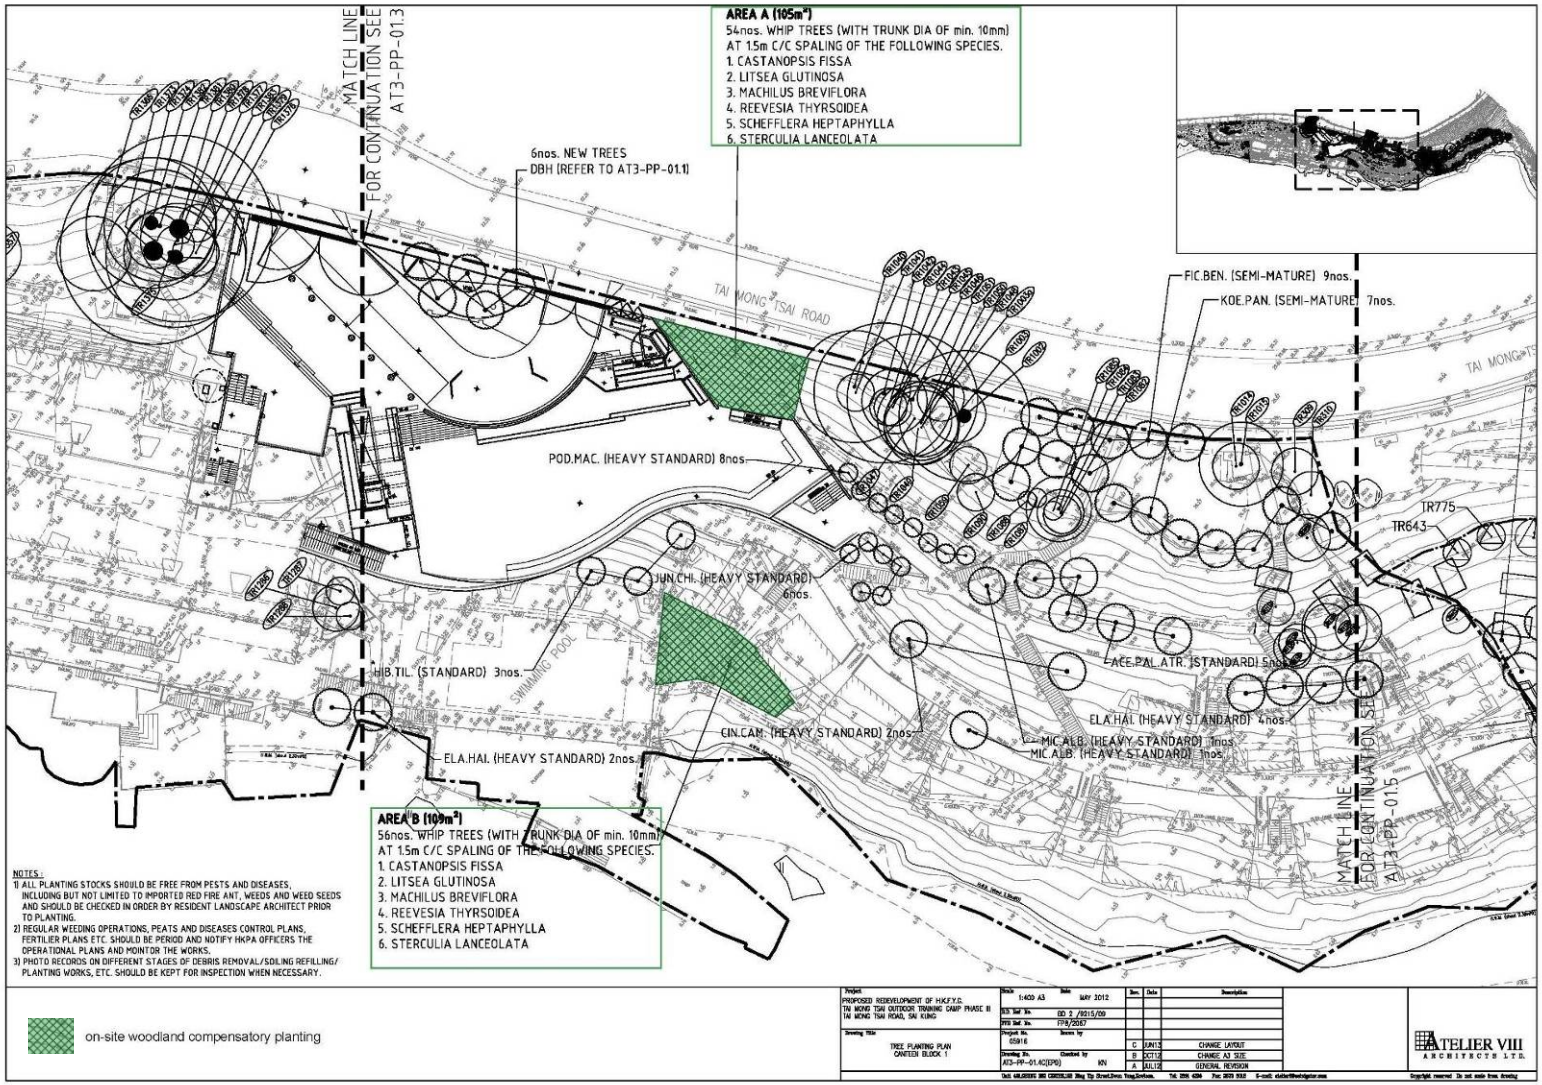
Figure 4.2 Amended On-Site Compensatory Woodland Planting Plan - Schedule of Drawings

4.1.6 The On-Site Woodland Compensatory Planting Plan was submitted to EPD on 11 September 2012 pursuant to Condition 3.3 of the EP and FEP and was approved on 14 September 2012. An amended On-Site Woodland Compensatory Planting Plan was submitted to EPD on 25 September 2013 and approved on 11 October 2013. **Figure 4.2** shows the approved amended plan and planting specification. Planting was completed on 25 November 2013 and is under the maintenance period.

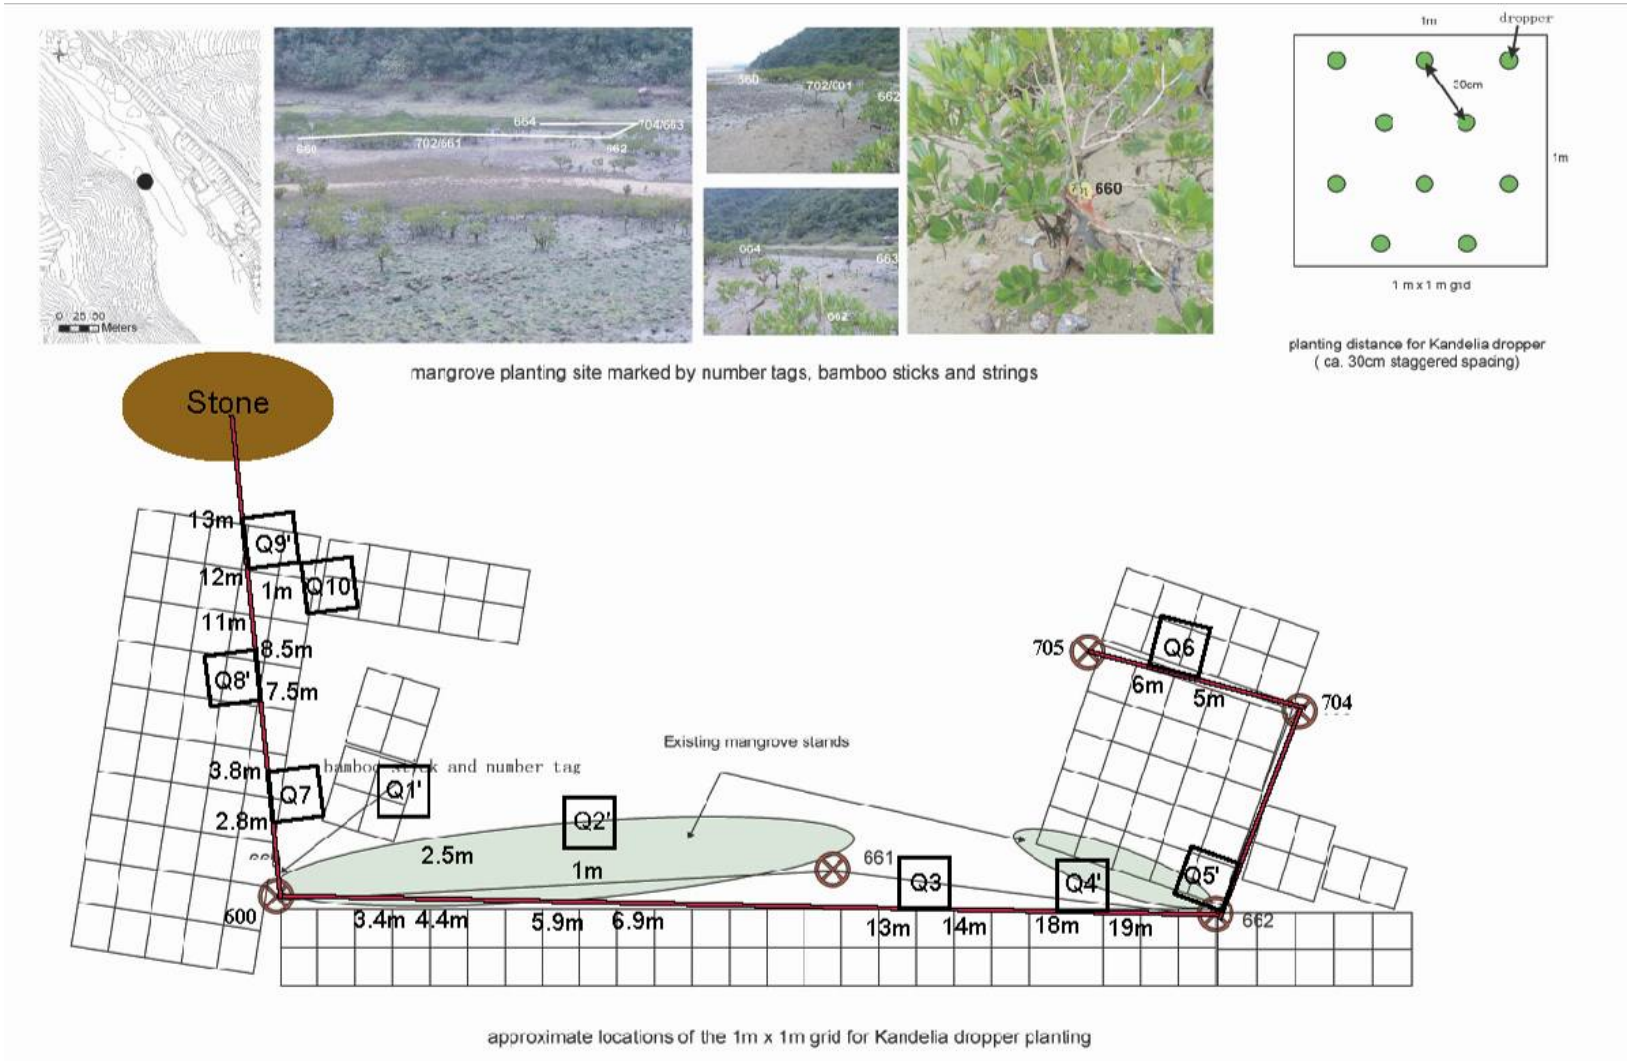
Figure 5.2 Mangrove Compensatory Planting Site and Sampling Locations

5.2.2 Planting was commenced and completed on 29 April 2011. About 1243 droppers of *Kandelia obovata* were planted on about 0.01 ha of sandflat following the protocol in the mangrove planting plan under the supervision of the ET. The planting area was further fine-tuned to avoid rocky/shallow substrate to enhance the survival (**Figure 5.2)**.
