Phase III Redevelopment of The Hong Kong Federation of Youth Groups Jockey Club Sai Kung Outdoor Training Camp

Environmental Monitoring and Audit Report for February 2013

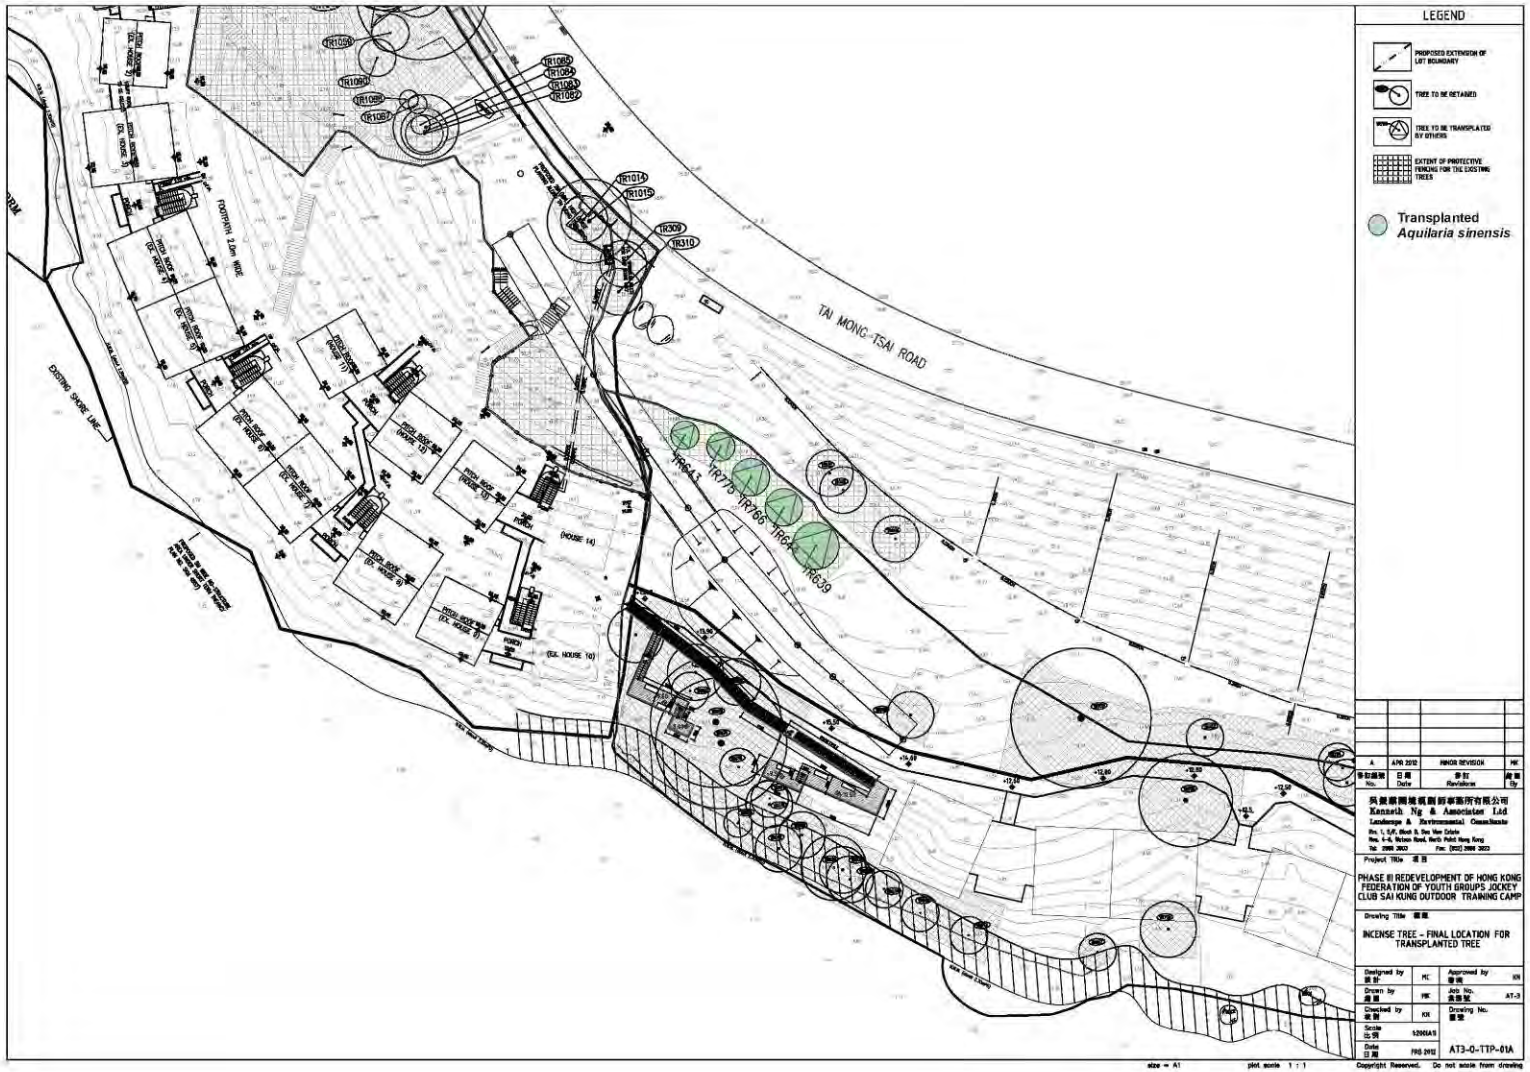
Figure 4.1 Location Plan for the Transplanted *Aquilaria sinensis*

4.1.4 Transplantation of the 5 trees was completed on 12 March 2012. Tree protection fence for the transplanted trees was installed after. The locations of the transplanted trees were fine-tuned in according to the site conditions and are shown in **Figure 4.1**.

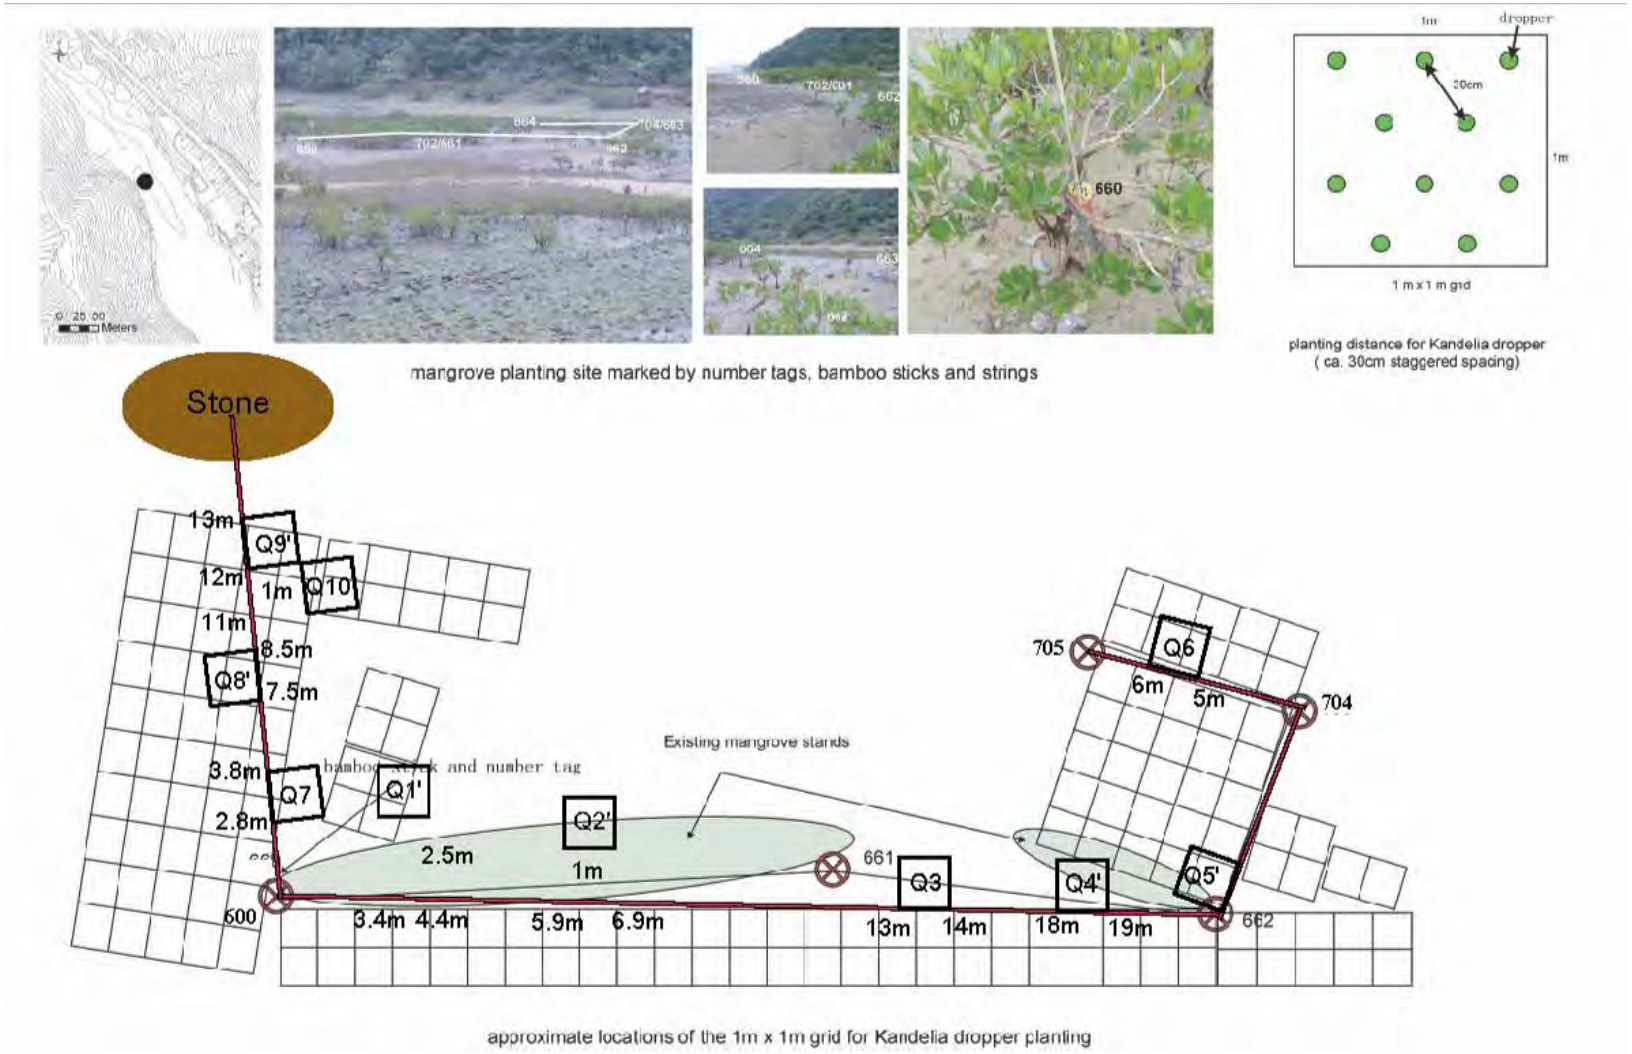
Figure 5.1 Mangrove Compensatory Planting Site and Sampling Locations

5.2.2 Planting was commenced and completed on 29 April 2011. About 1243 droppers of *Kandelia obovata* were planted on about 0.01 ha of sandflat following the protocol in the mangrove planting plan under the supervision of the ET. The planting area was further fine-tuned to avoid rocky/shallow substrate to enhance the survival (**Figure 5.1)**.

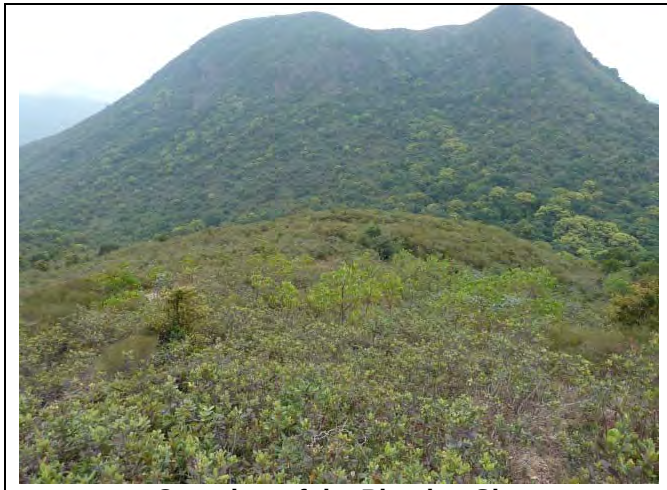
Figure 5.3 Photo Records of Tree Whip Planting, February 2013

5.3.3 Monitoring frequency was resumed to quarterly and was conducted in 20 February 2013 to audit the replacement planting to be conducted and to check the growing conditions of the plants. Photo records of the planting and monitoring were shown in **Figure 5.3**.

5.3.4 Similar to the observation in November 2012, individuals of the six planted species were in fair to poor conditions. Of the survived seedlings, *Schima superba* had the best performance so far. New healthy leaves developed during the past growing season formed more developed crowns, and little signs of stress or damage were observed. Other species including *Schefflera heptaphylla, Castanopsis fissa, Machilus* sp., *Sterculia lanceolata*, and *Litsea glutinosa* were in fair to poor conditions. Some of the individuals showed a few small resprouted leaves while herbivory were also observed. Monitoring will continue to audit the replacement planting to be conducted and check the growing conditions of the plants.

11.1.2 Monitoring results of off-site woodland compensatory planting in February 2013 at Lui Ta Shek ranged from fair to poor. According to the Event and Action Plan for Ecological Impact, actions due to non-compliance were taken in accordance with the action plan. IEC has been informed. A remedial action proposal including replacement planting, which will be re-scheduled to April 2013, was submitted to the Project Proponent. Monitoring will continue to monitor remedial actions until rectification has been completed.
