Phase III Redevelopment of The Hong Kong Federation of Youth Groups Jockey Club Sai Kung Outdoor Training Camp

Environmental Monitoring and Audit Report for April 2014

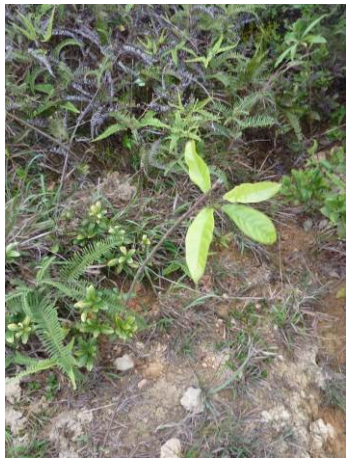
Overview of the Site
